# Case Study

## Zenith™ Amniotic Membrane

Case presented by Jacob Fassman, DPM; Podiatrist;  
Colorado Foot and Ankle; Colorado Springs, CO

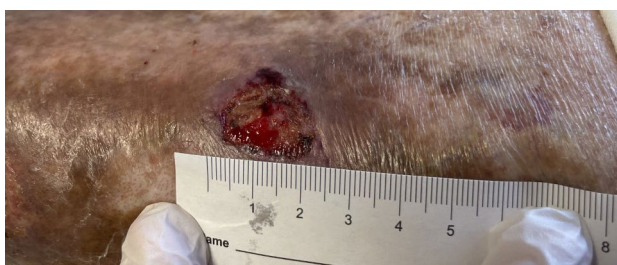
**WEEK 1** Debridement with application of 2 x 3 cm Zenith

Size: **2 x 1.5 x 0.1 cm**

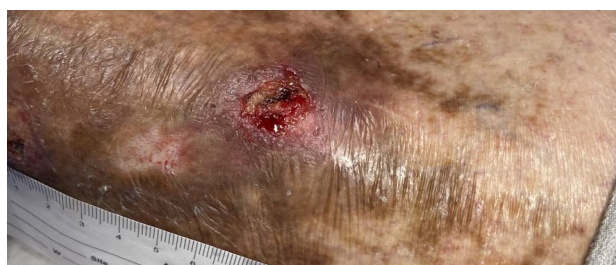
**WEEK 2** After debridement, application of 2 x 3 cm Zenith

Size: **1.6 x 1.3 x 0.1 cm** | Volume reduced: **31%**

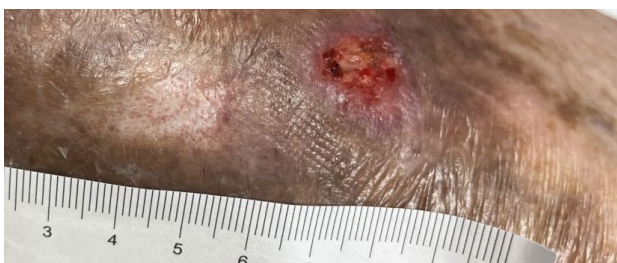
**WEEK 3** After debridement, application of 2 x 3 cm Zenith

Size: **1.3 x 0.9 x 0.1 cm** | Volume reduced: **44%**

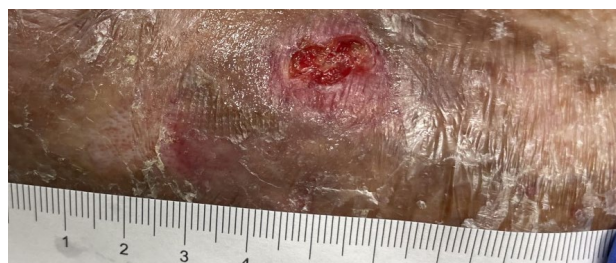
**WEEK 5** After additional Zenith in week 4, patient is improving; fifth 2 x 3 cm Zenith applied after debridement

Size: **1.2 x 0.5 x 0.1 cm** | Volume reduced: **49%**

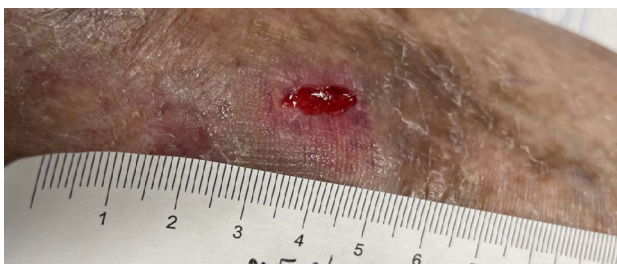
**WEEK 6** After debridement, application of 2 x 3 cm Zenith

Size: **1.3 x 0.3 x 0.1 cm** | Volume reduced: **35%**

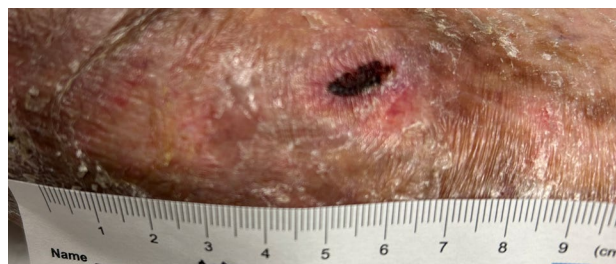
**WEEK 8** After additional Zenith application in week 7, wound healed

Size: **Wound resolved**
